M and M in Gander - A bomber crash that could have gone really badly

(by Robert G Pelley 15-09-2017)
<http://bobsganderhistory.com>

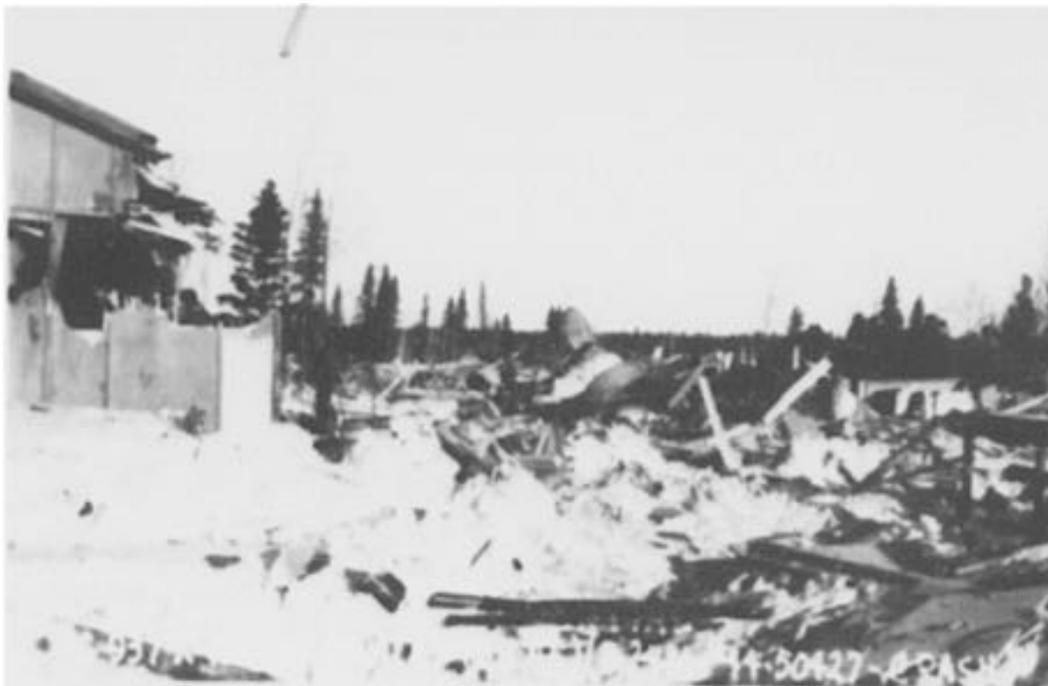
Damage to barrack (USAAF photo)

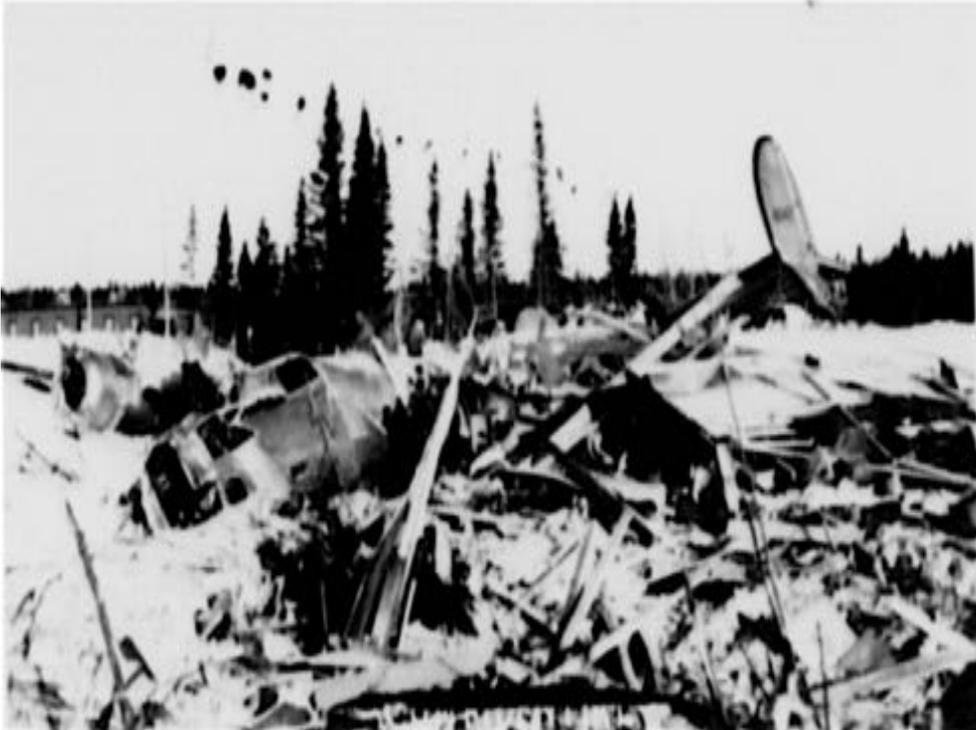
In any case, the photo below shows the result as far as both the airplane and the United States Army Air Force was concerned:
