## A slippery day in Gander - Seaboard and Western Geneva Airtrader

(by Robert G Pelley, 05 November 2017)

From the days of the first Hudson bombers to cross the Atlantic in November 1940, pre-winter weather in Gander was known at best as unpredictable and at worst as treacherous. Those were the conditions when a Seaboard and Western DC-4, serial N75415, named the "Geneva Airtrader", attempted to land in Gander on 22 November 1955.

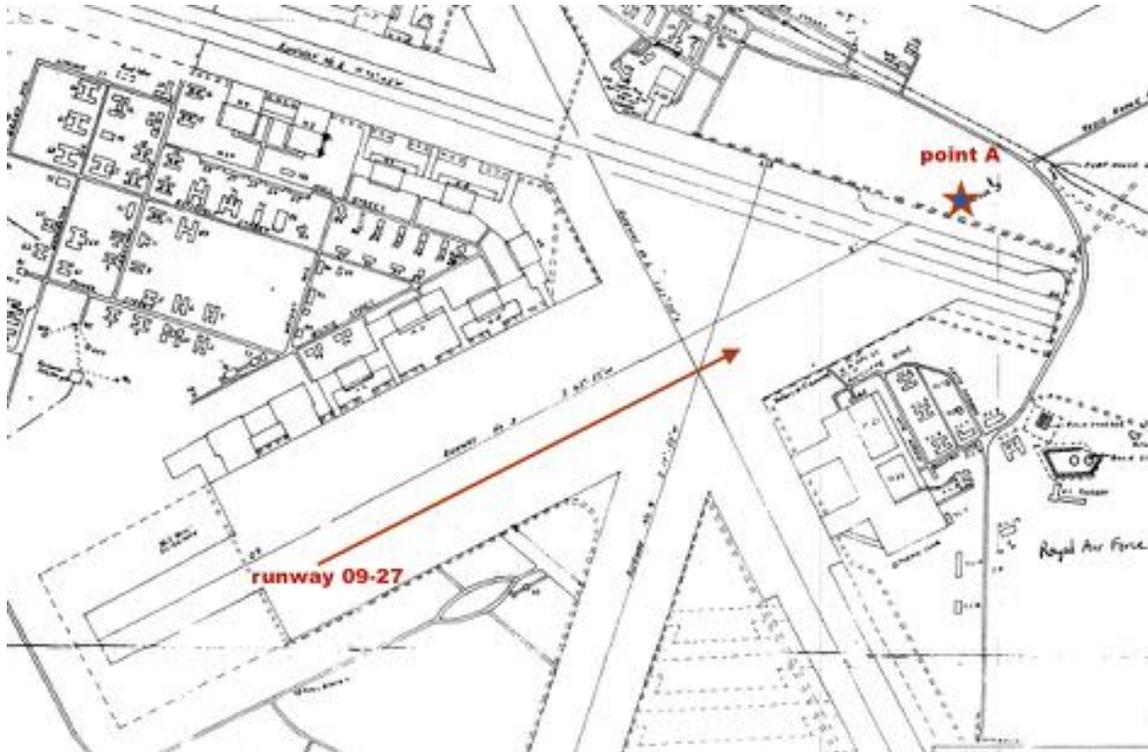
At about 1147 GMT, the aircraft contacted Gander Tower and was cleared for a standard Instrument Landing System approach on runway 09. The aircraft touched down in what appeared a normal manner - but continued down past the end of the runway. It then rolled about 55-60 meters over half-frozen earth and then crossed and hung up on a ditch about 6-7 meters wide.

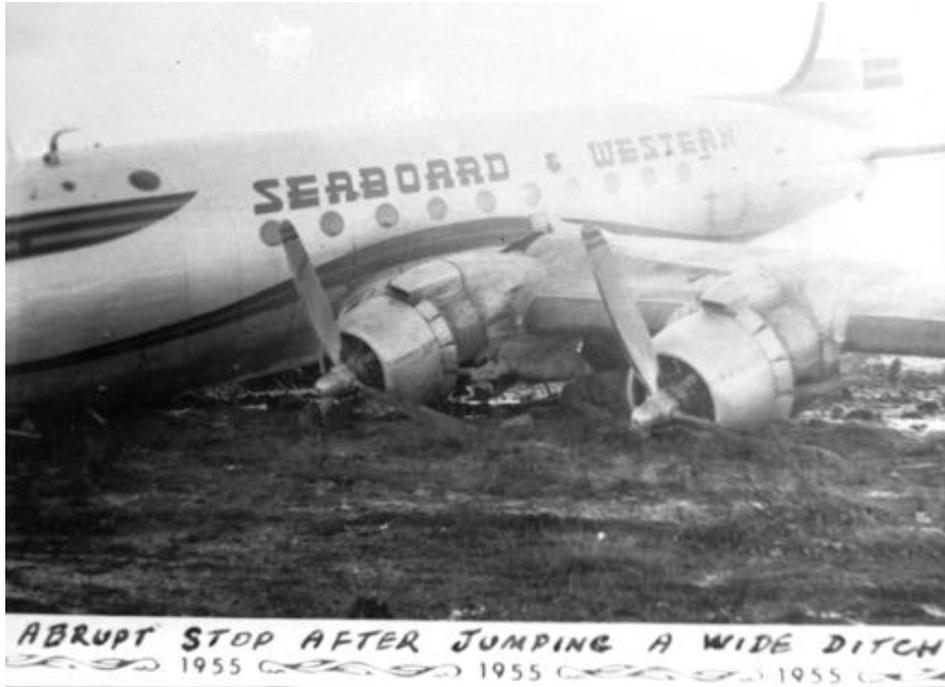
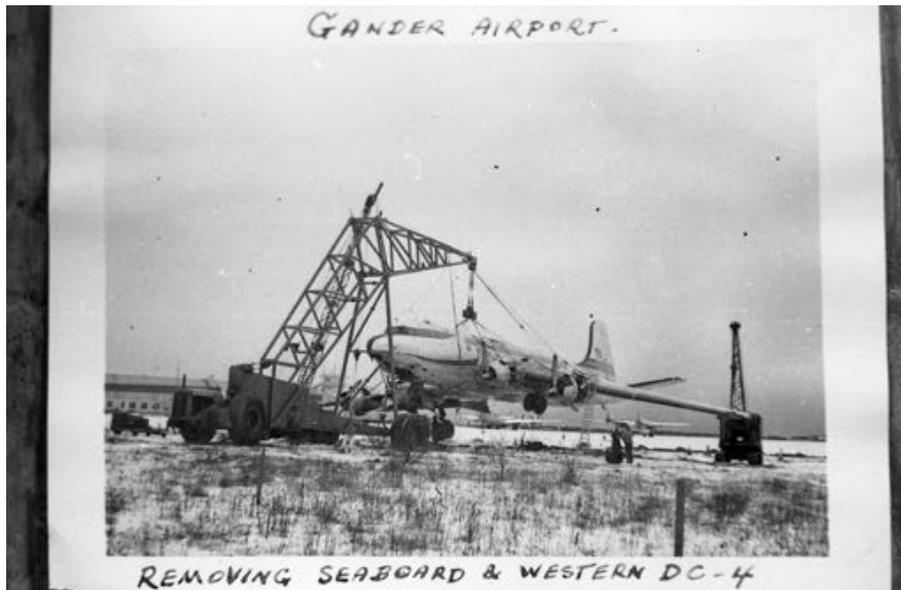
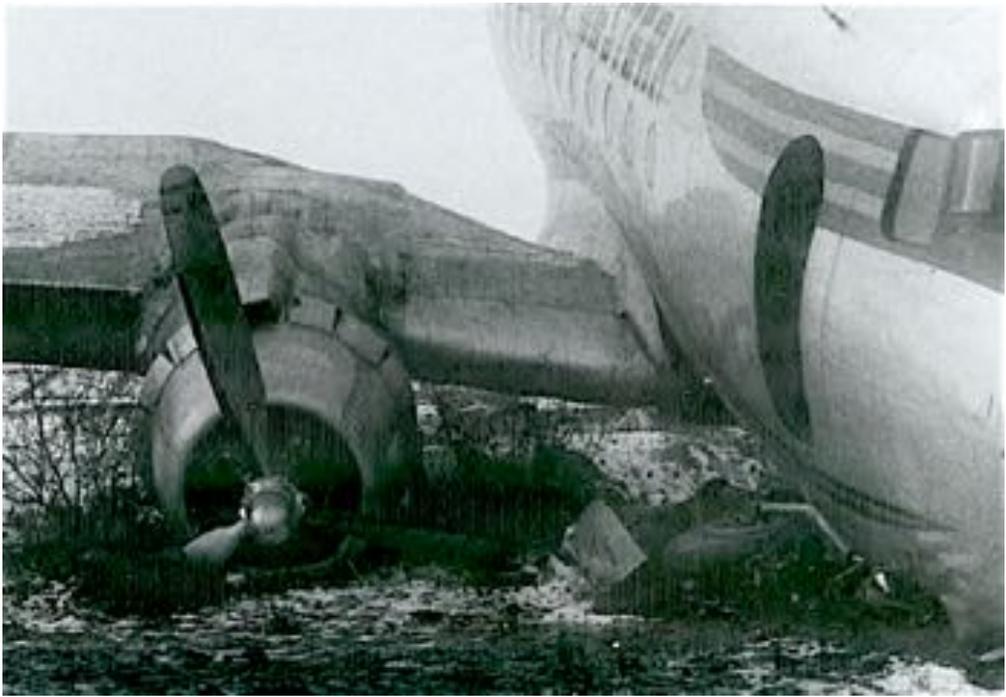
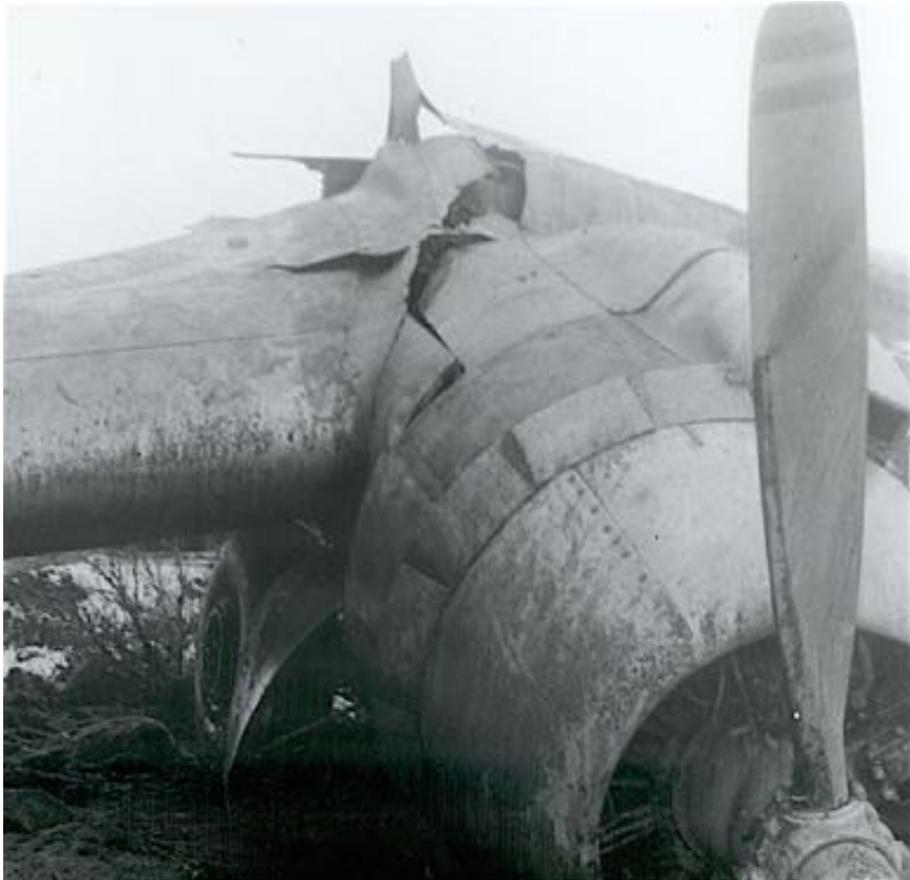
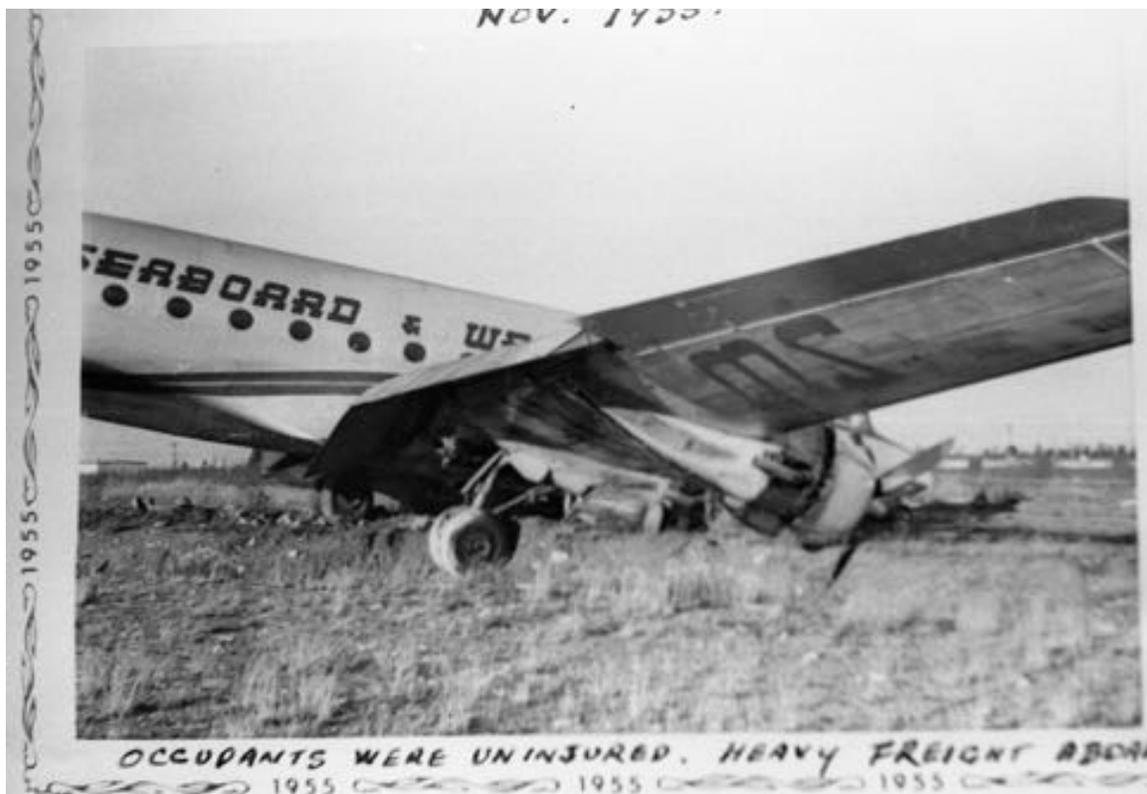
While there were luckily no fatalities or even injuries, it is certain that given the weight and conditions, severe damages were inevitable.

The following is general type of damages to engines, props, landing gear, fuselage and wings as given in the official account of what happened:

Thanks is given to Darrell Hillier for several of the photos below, which let us better see the damages.
