M and M in Gander - A bomber crash that could have gone really badly

(by Robert G Pelley 15-09-2017)
<http://bobsganderhistory.com>

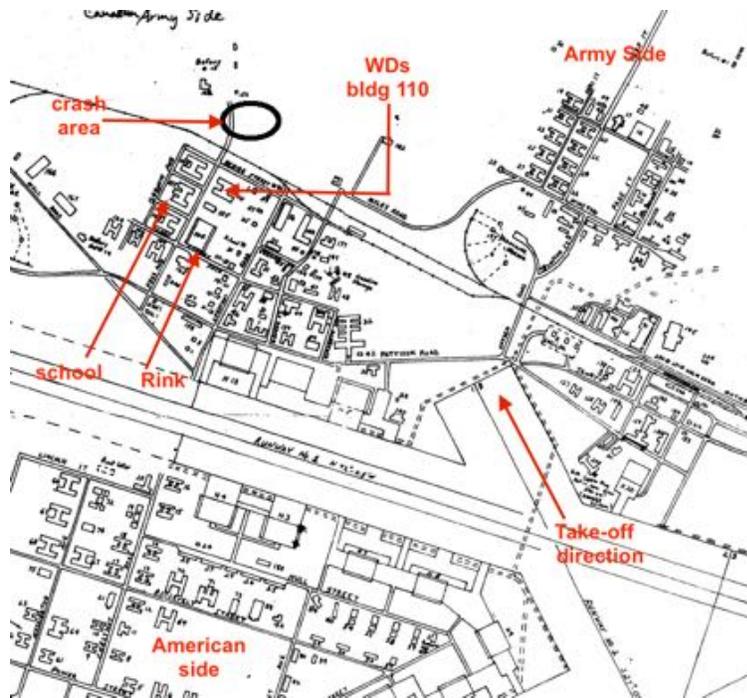
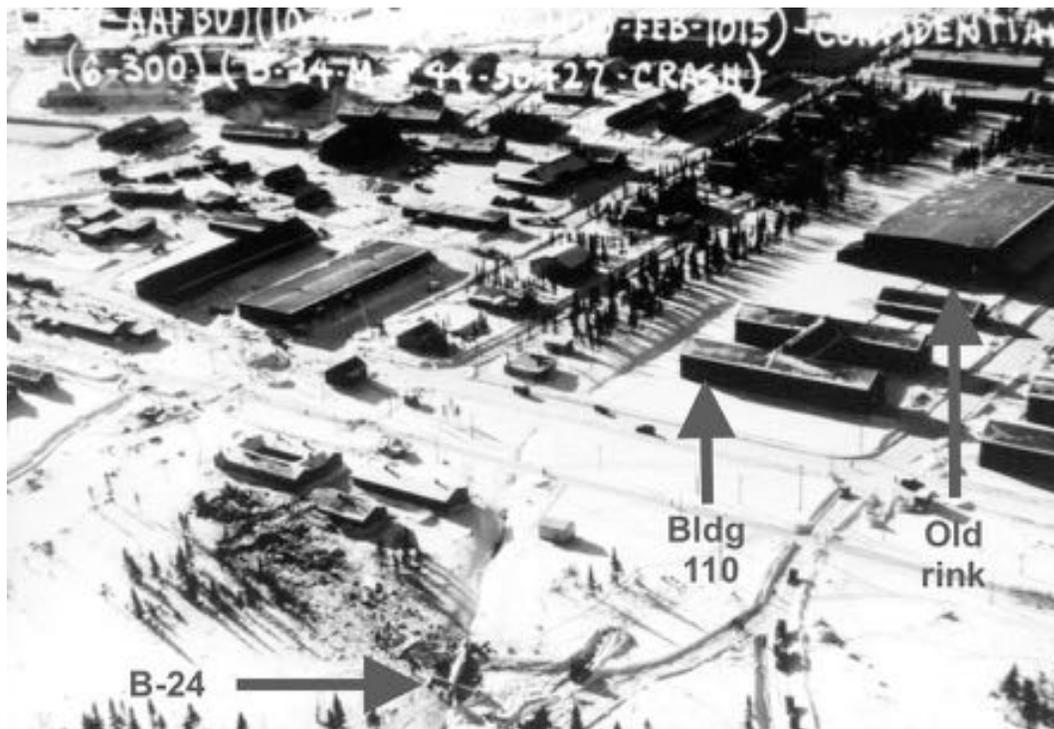
(USAAF photo)

Following the take-off, the aircraft continued in flight, with the left wing slightly lower than the right, and made a very slow turn, totalling about 10 degrees, to the left of the take-off line, to the point where wreckage came to rest. In the process, numerous power and communication lines were torn down, tops were broken from two (2) telephone or power poles, and three (3) other poles were knocked down. Just beyond this point, the aircraft hit, and completely demolished two small frame barracks and damaged two others. Two people (who were not injured) were sleeping in one of the damaged barracks but the others were unoccupied. The aircraft began to come apart when the first pole was hit and parts were well-scattered along its track, until it came to rest in a deep ditch about 50 yards beyond the barracks it had knocked down.

For people who are familiar with the old Hunt Memorial Academy and the old skating rink on Foss Avenue, this crash was a short distance past the end of Foss, just north of the railway tracks.
